INVENTORY FORM FOR STATE HISTORIC SITES SURVEY

Dandy Hall

102 North Liberty Street

QA-317

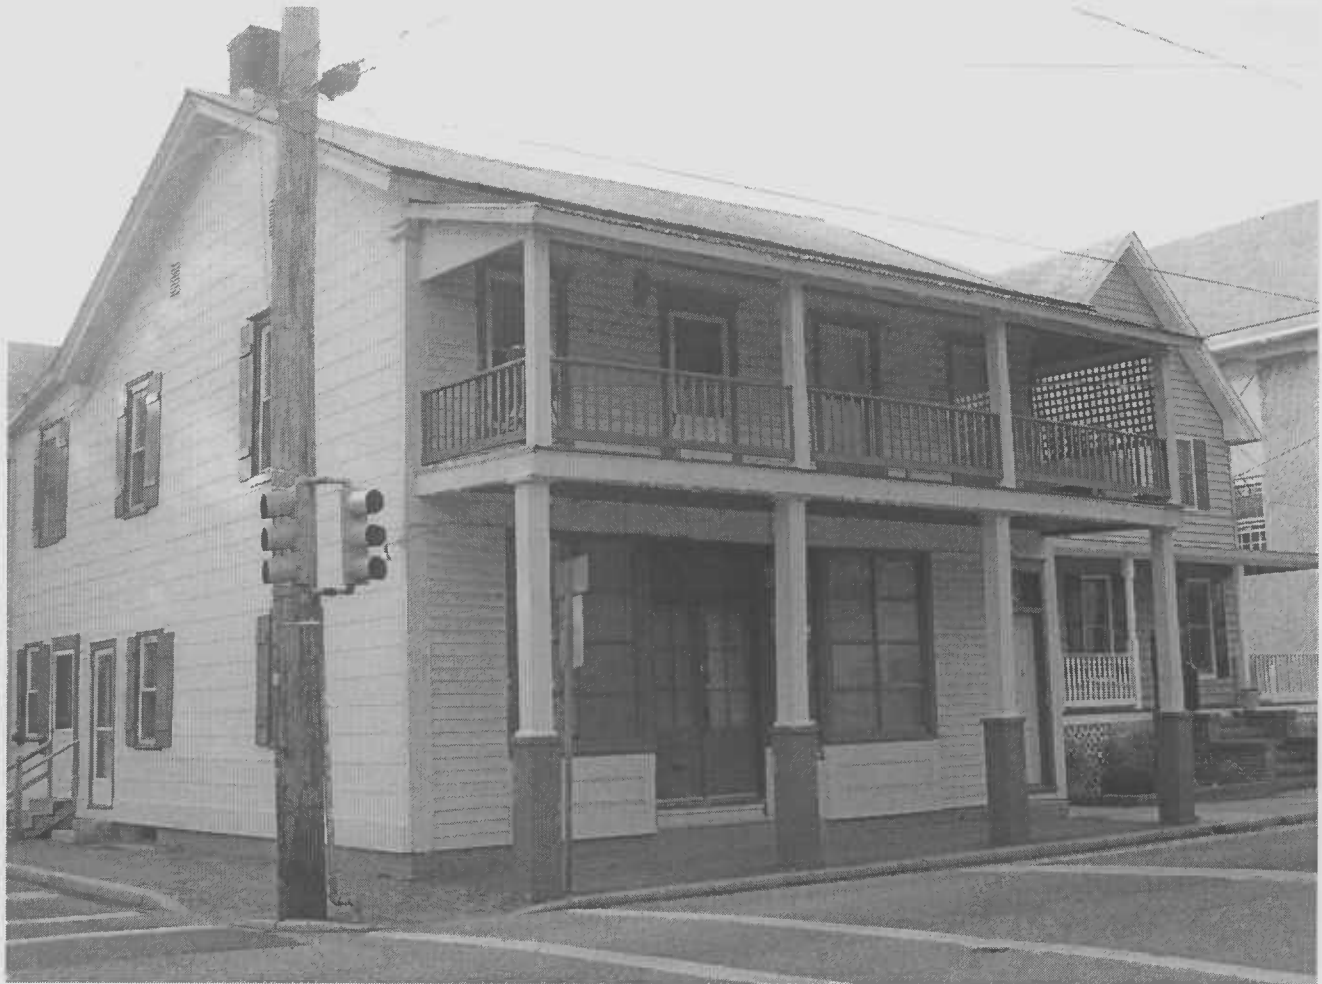
QA-317
Dandy Hall

Mary McCarthy
Spring/Summer 2003
Digital color photo on file at MHT

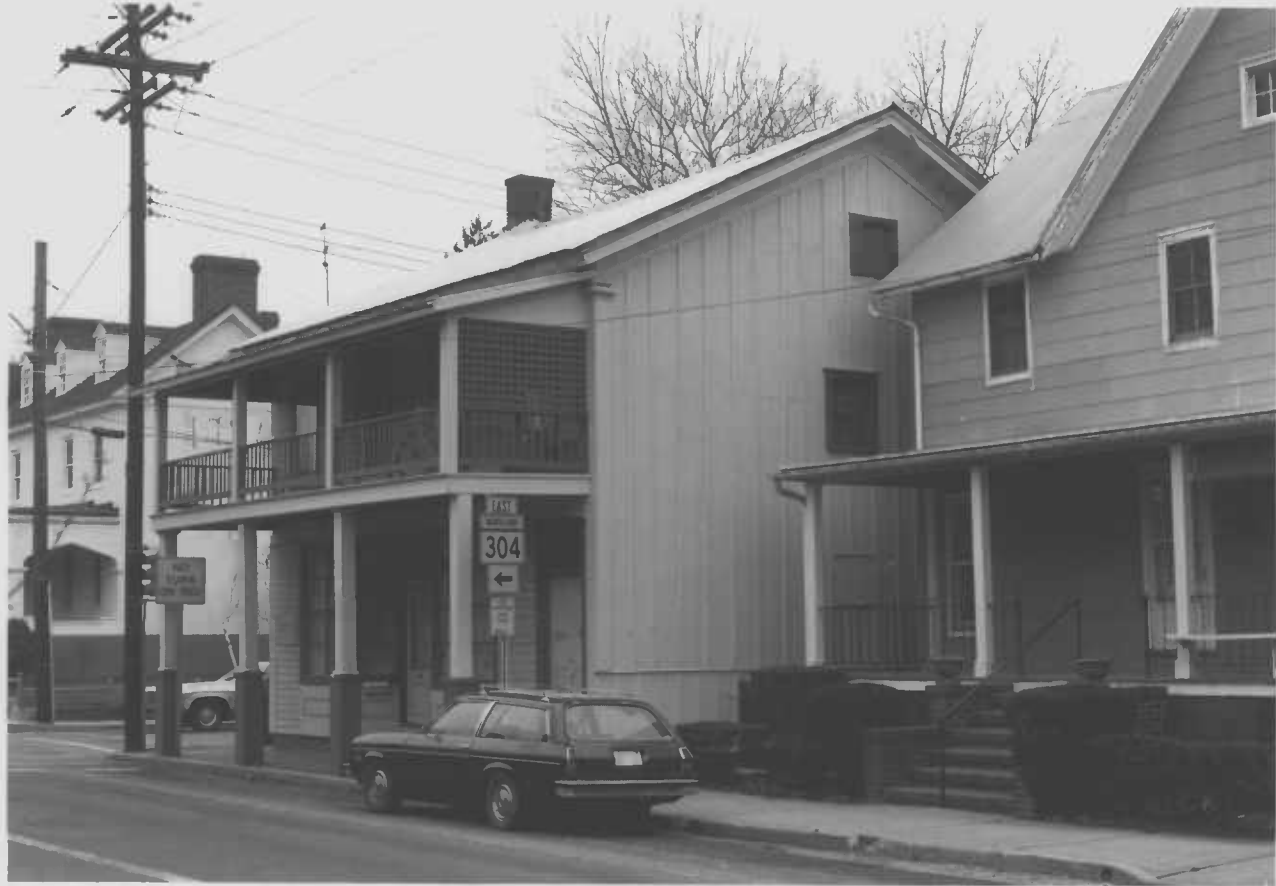
QA-317

The north gable has asymmetrical fenestration, with all of the openings shifted toward the rear of the building, in large part due to the stair hall. On the first floor, there is a small six-light sash near the center and a 6/6 window to the rear. On the second floor there is a six-light sash near the center and two 6/6 windows to the rear. A louvered vent in the upper gable replaced an earlier semi-circular vent.

Dandy Hall
102 North Liberty St.
Centreville, Maryland
Orlando Ridout V 1980
View from Northeast

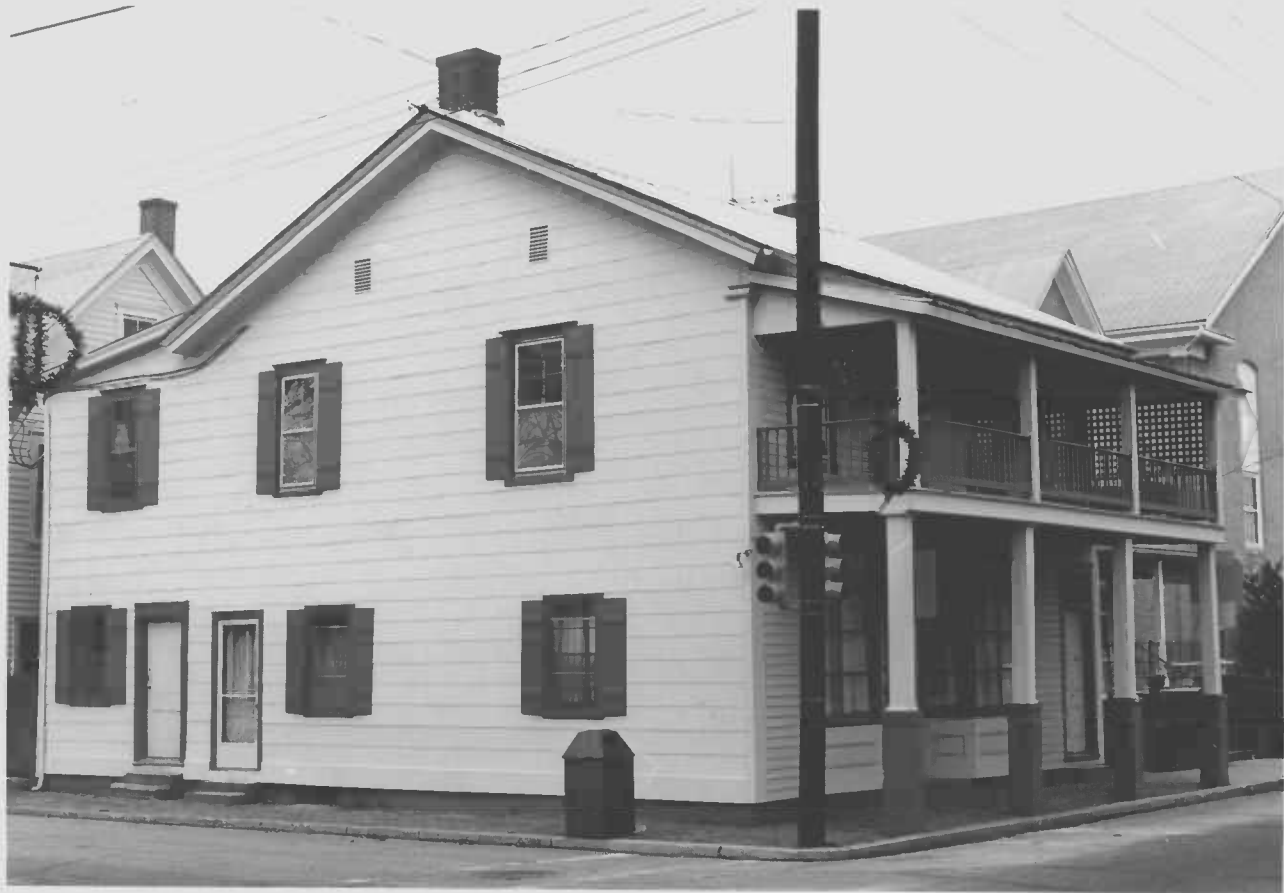
QA-317

Dandy Hall is located on the northwest corner of Liberty Street and Water Street in Centreville. It is a two story frame building with a pitched gable roof, two story open porch on the front facade, facing Liberty Street, and a two story frame lean-to addition to the rear.

On the south gable of the original section, there are 2/2 windows flanking a flush brick

stove chimney on the first floor, a 2/2 to the left of the chimney on the second floor and a 4/4 to the right, and a pair of louvered vents in the upper gable. A pair of "transom" windows between the first and second floor do not line up with the other openings. There is a single paneled door at the extreme left side on the first floor. The rear lean-to is only one bay wide, with a door on the first floor and a 2/2 window on the second floor.

Dandy Hall
102 North Liberty St.
Centreville, Maryland
Orlando Ridout V 1980
View from Southeast
